Federal Facility Emergency Generator Fuel Quality Study Multi-State

INTRODUCTION AND BACKGROUND

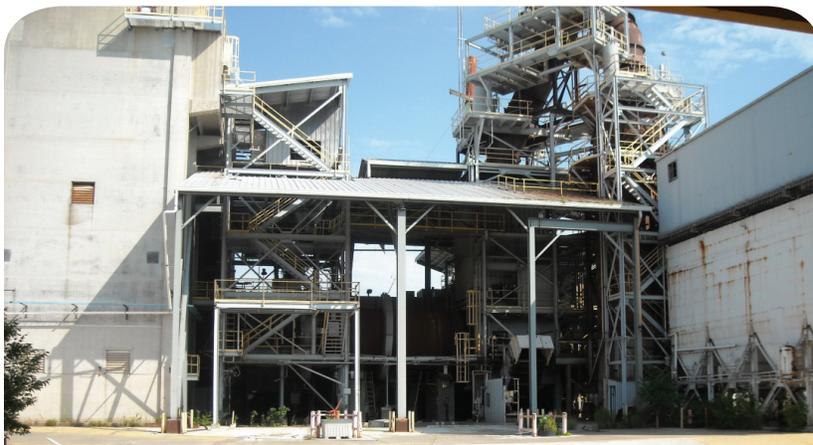
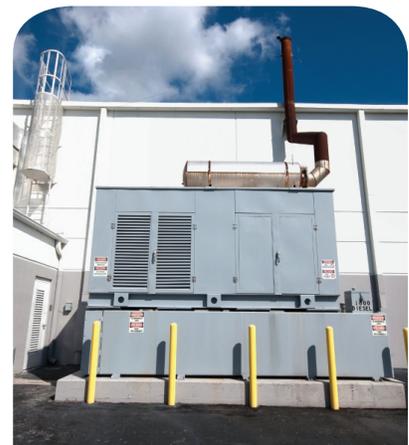
Samples were collected from each tank bottom using a stainless steel, bottom-filling sampling device. The fuel analysis results for each of the 11 facilities are summarized in Table 2 below:
